CATNIP II – Electronics Upgrades Part 2

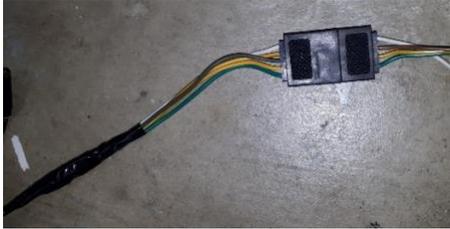
Part 1, covered preparations for installation of a Lowrance HDS9 sonar/chartplotter. The dash panel was fabricated and ready for installation. The connections between the HDS9 and the Standard Horizon GX2150 VHF radio were made with flat 4 trailer light connectors.

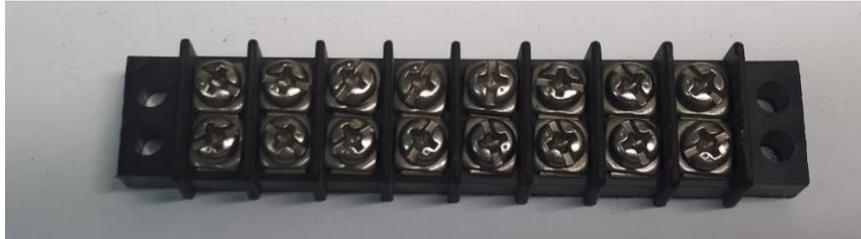
Both the Lowrance HDS9 and the Standard Horizon GX2150 have RS 422 connections. The HDS9 manual identifies the NMEA 0183 wires as RX_A, RX_B, TX_A and TX_B. The GX2150 manual identifies them as RX+, RX-, TX+ and TX-. Obviously the RX wires of the GX2150 connect to the TX wires of the HDS9 and vice versa but there are two ways to connect each pair. Some experimenting was needed. To make this easier, I purchased a terminal strip.

I connected the wires from the VHF radio to one side of the strip and the wires from the HDS 9 to the other side. It was easy to interchange the connections until everything worked. After a little experimenting, I discovered that

<u>HDS 9</u>	<u>GX 2150</u>
RX_A (orange)	TX+ (Gray)
RX_B (green)	TX- (Brown)
TX_A (yellow)	RX+ (Blue)
TX_B (blue)	RX- (Green)
