CATNIP II – Electronics Upgrades

Part 1

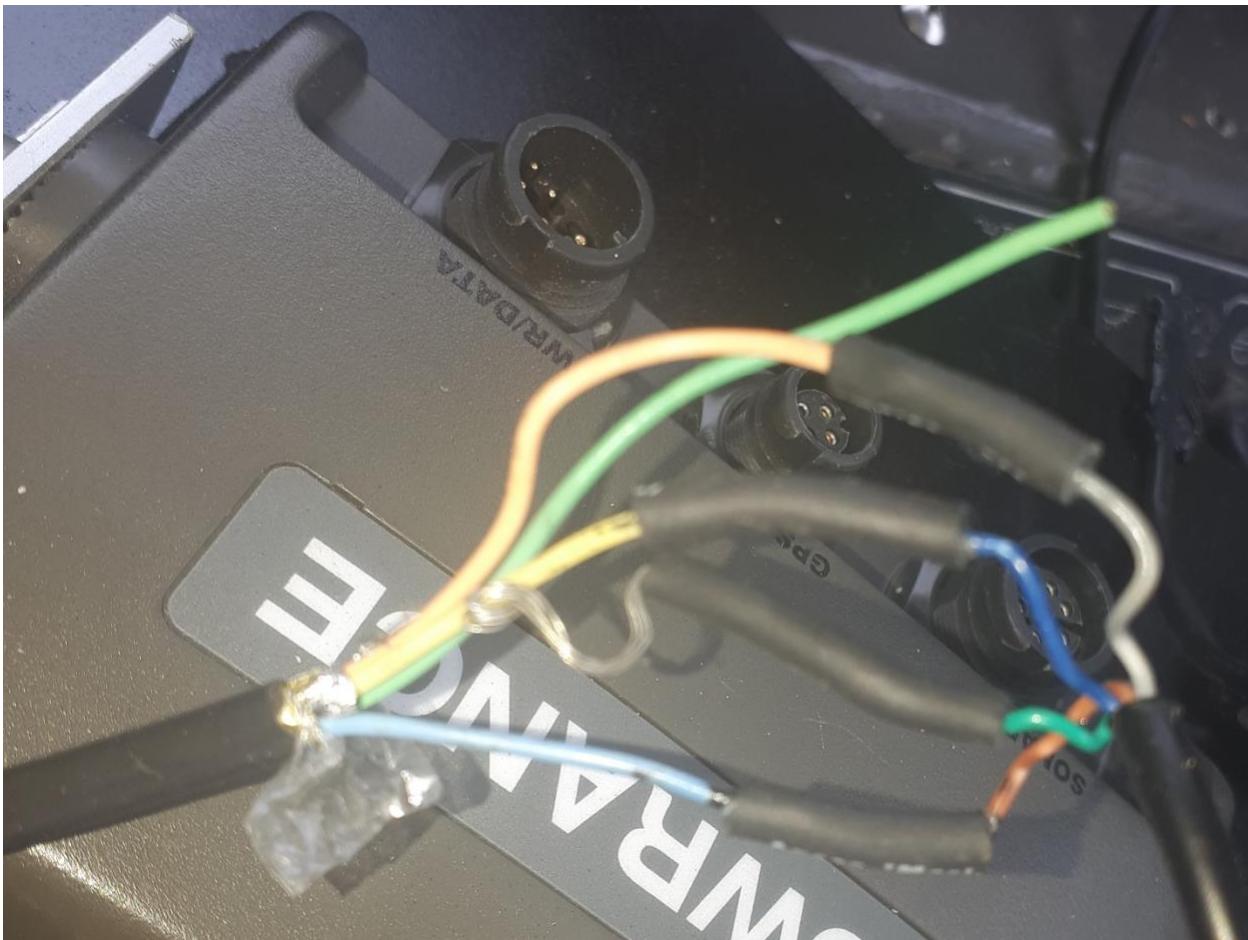
I don't trust crimp connectors, even the marine grade variety. When I installed the radio, I made connection to the HDS8 by soldering the wires. To remove the radio I had to take off the dash plate and cut the wires.

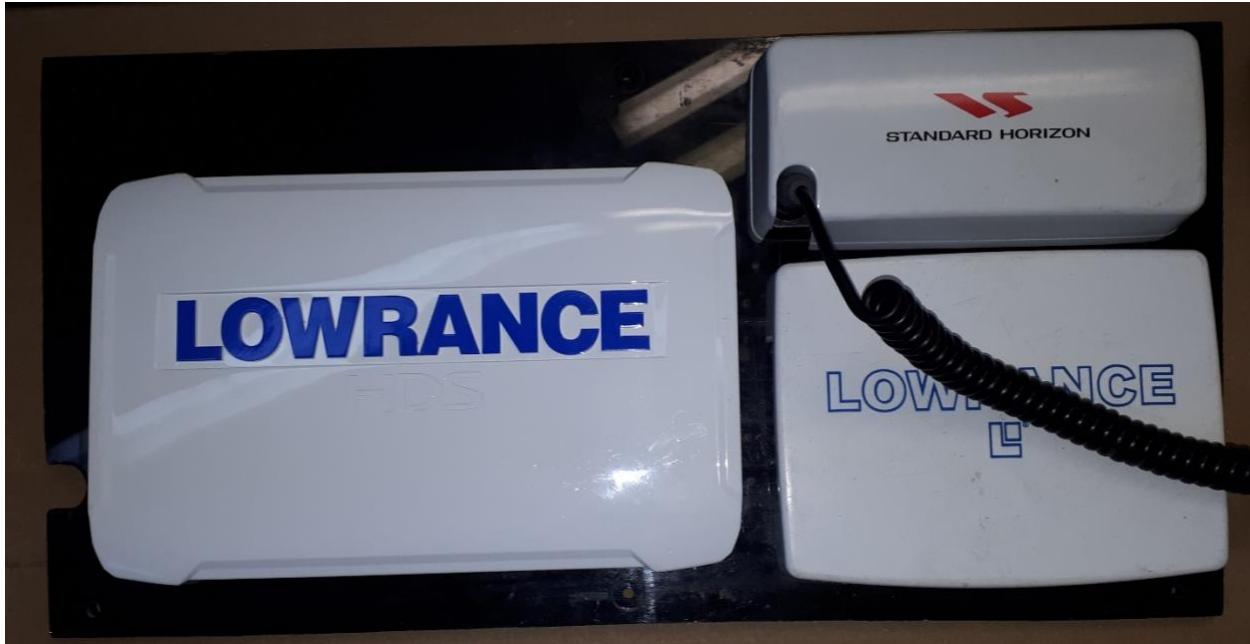
When I first bought the boat, I fabricated a new dash panel and flush mounted the original LMS-240 sonar/chartplotter and the Raymarine VHF radio. When I purchased the HDS8 I installed it in a bracket in front of the LMS-240. This avoided modifications to the dash panel and allowed me to retain the LMS-240 for backup. Also I could easily remove the HDS8 for winter storage. With the dash completely disassembled, I decided to flush mount the HDS9, the LMS-240 and the VHF radio in the dash panel.

In early January, I got the VHF radio back. First I powered it up to make sure it worked. After some experiments, I decided that the dash panel would (barely) accommodate the all three units. This was eventually accomplished, but not without effort. The $\frac{1}{2}$ " thick Plexiglas that I used to make the dash panel is NOT easy to cut.

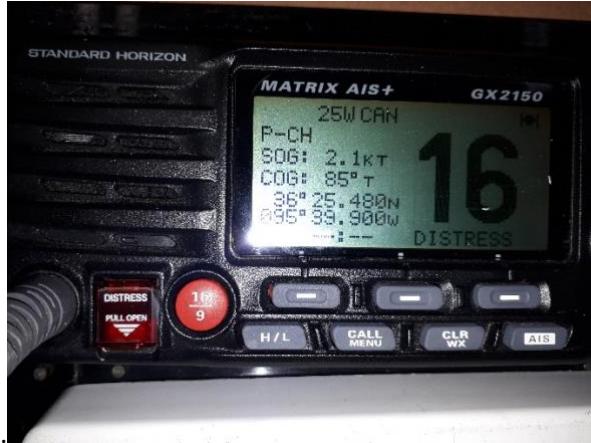
To make things easier in the spring, I wanted to test the connection between the VHF radio and the HDS9. To do this, I needed to power them both up and connect the NMEA 0183 wires. I laid the dash panel on top of a cardboard box and cut matching holes to let the equipment sit down properly. Then I cut a hole in the side of the box to access the wiring.

First I hooked the radio and the HDS9 to 12V power. When I removed the radio, I cut the NMEA 0183 wires on the GPS side. This made it easy to reconnect them. I just twisted the wires together matching the colors from the HDS8. Since I was in the basement, the GPS couldn't get signals to calculate a real position. I set the HDS9 to simulate mode. The simulated position and speed displayed on radio screen indicated that connection was correct.
