CATNIP II – Electronics Upgrades Part 3

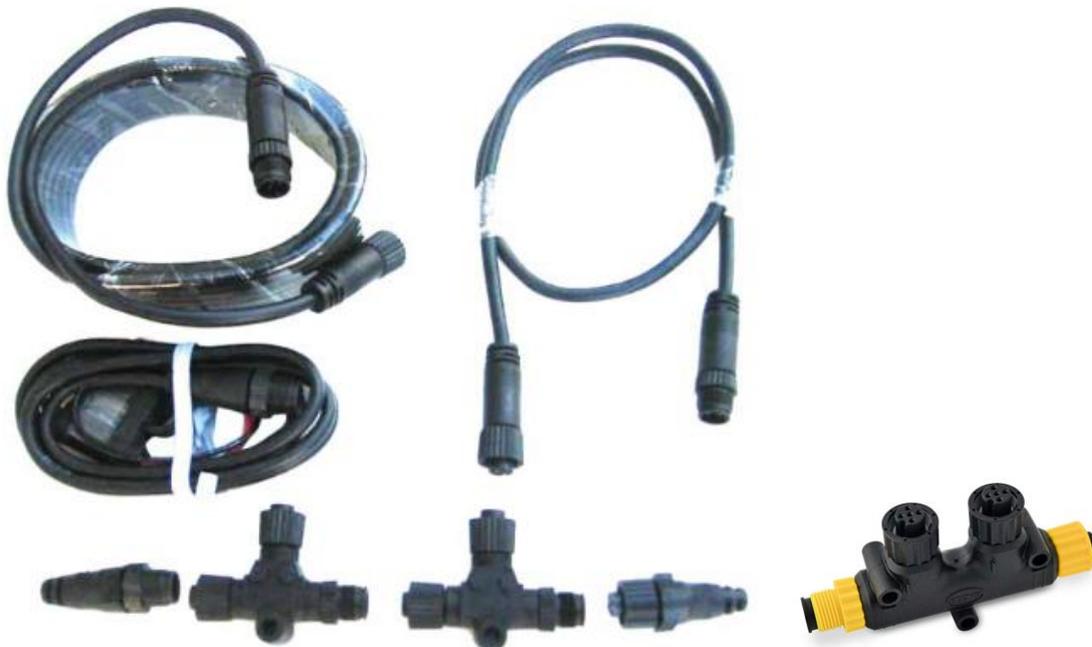
In order to run tests, I needed a temporary NMEA 2000 connection between the ICOM M506 and the HDS9. I bought a NMEA 2000 network starter kit which included two connection tees, two drop cables, two terminators and a power cable. Since the power supply and each connected device need a separate connection, I needed one more tee. I purchased a tee with two connections. This left me a spare tee for future use. I had to rig temporary power connections for the HDS 9, the new radio and the NMEA 2000 network.

It quick and easy to assemble the NMEA 2000 network. The chart plotter immediately recognized that the ICOM M506 radio was connected. I put the HDS 9 in Simulate Mode but the simulated GPS position

did not appear on the radio screen. After some head scratching, I relocated the whole setup close to a window where the HDS 9 could receive satellite signals. The GPS position from the HDS 9 then appeared on the ICOM M506 screen. Confident that everything was going to work, I waited for spring.

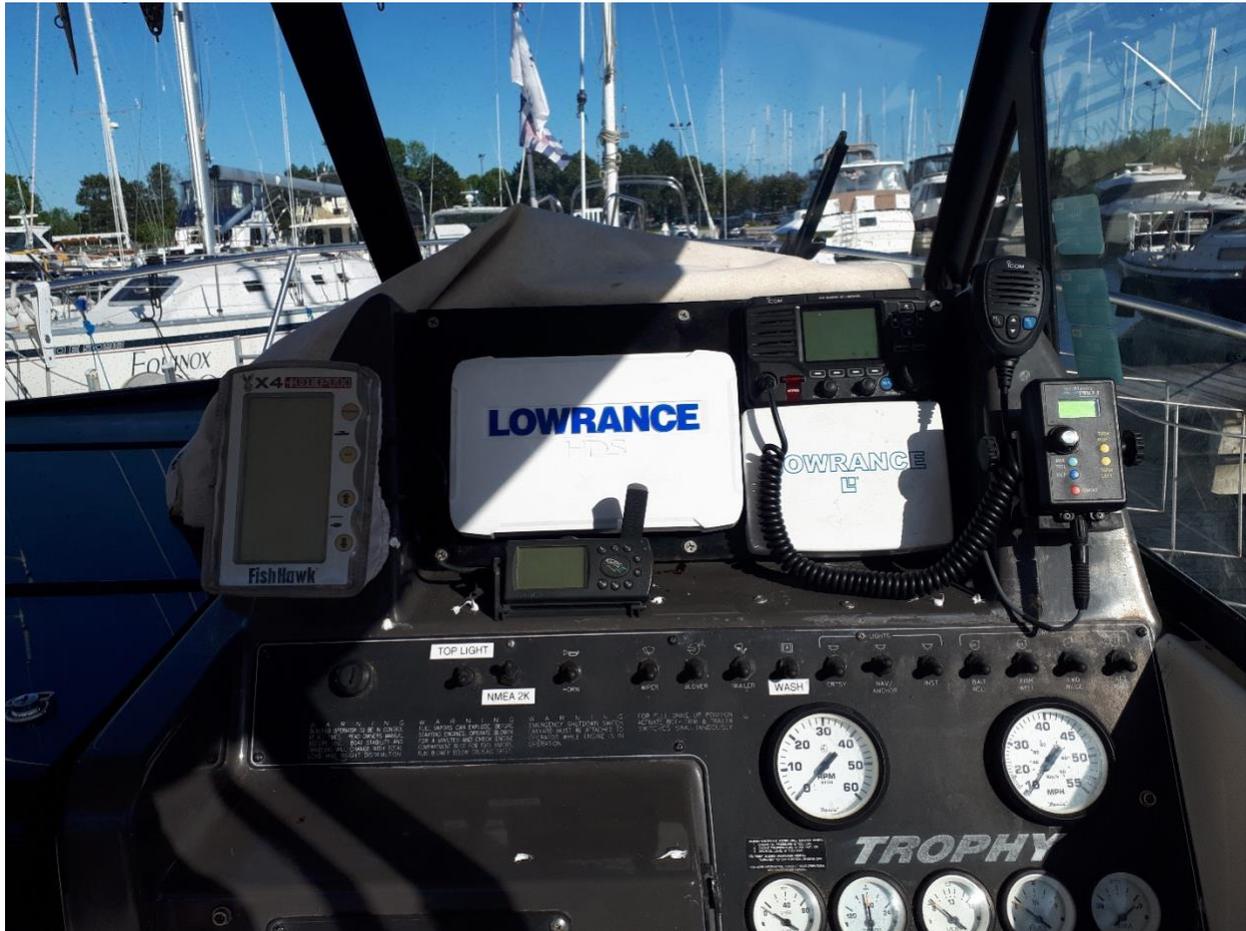
Due to Covid-19, the wait was longer than expected. Finally I was able to remove the shrink wrap from the boat and complete the installation. The dash panel modification was touch and go but I was able to make everything fit. All the electronics are now installed and working, even the automated fog signal.
